# **A LABORATORY STUDY OF TYPES OF CORROSION INDUCING HYDROGEN PERMEATION THROUGH STEEL**

F.W.H.Dean  
Ion Science Ltd

S.W.Powell  
Ion Science Ltd

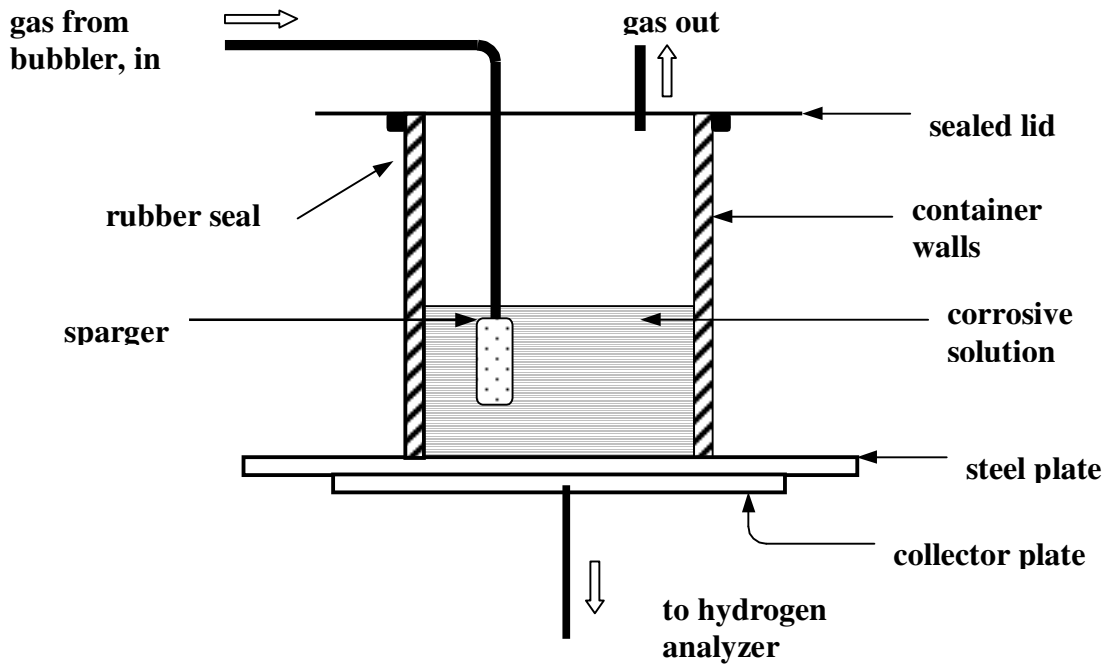
**Figure 1a.** Schematic representation of equipment used in exit surface flux evaluation

To investigate the effect of steel surface preparation on hydrogen efflux, one surface of Plate Steel (Table 1) was ground with p120 SiC paper to remove oxide coating and any other surface contaminant. It was then bonded with epoxy resin to a polypropylene cylinder (110 mm x 64 mm inner diameter), to form suitable containment means for the corrosive solution, as shown in Figure 1a. Over this was placed a stainless steel lid with a rubber seal to form an air tight seal. Silicon grease was applied around the rubber rim and at pipe junctions to ensure effective exclusion of ambient air. The lid included

two ports to enable the inward and outward flow of gases. Attached to the interior side of one port was PTFE tubing, terminating in a sparger at the steel base. The chamber was purged with nitrogen for at least 30 minutes prior to admission of pH 4.7 buffered NACE solution A. The corrosive solution was decanted from the air tight vessel directly into the cylindrical container, using PTFE piping attached to the outlet port of the container lid. A volume of 300 cc of corrosive solution was added. The flux probe was attached to the exit face of the steel plate, and demarcated around its perimeter to ensure repeatable positioning on detachment and reattachment.

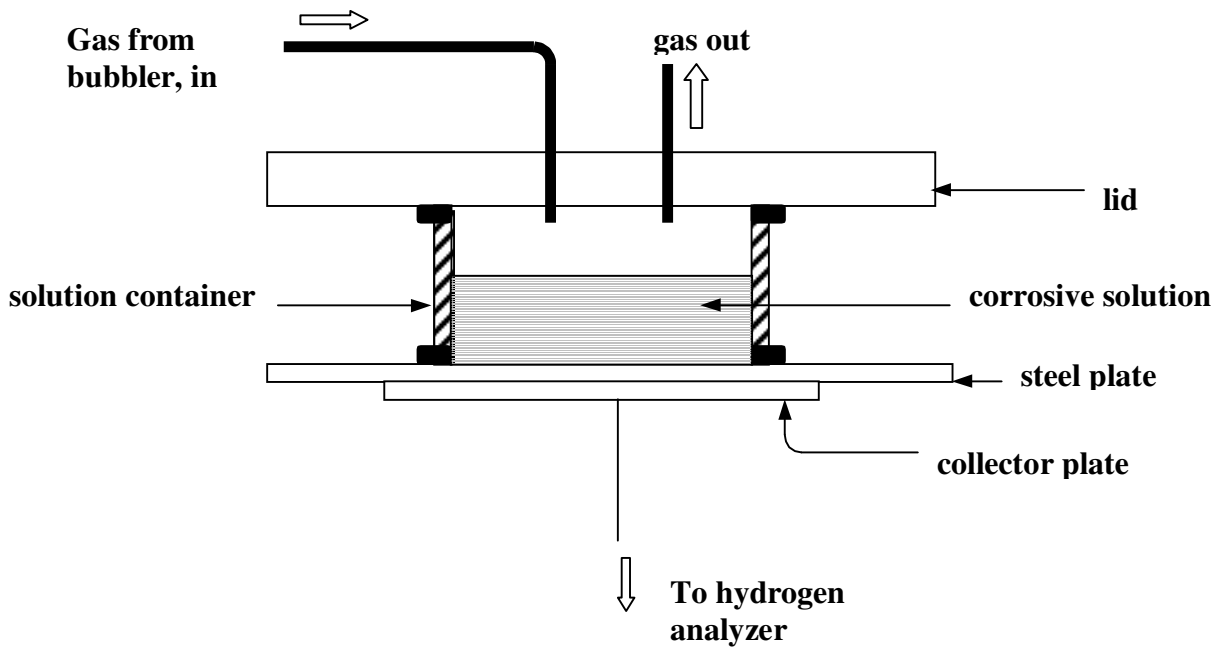
**Figure 1b.** Schematic representation of equipment used in entry surface flux evaluation

Apparatus was similar to that described above, as shown in Figure 1b. However, to ensure rapid transition between conditions of charge and discharge, the charging cylinder was in this case attached to the test steel by means of a rubber seal between them, which, prior to attachment, had been smeared with silicone grease. Also, the lid of the charging container comprised a copper disc (500 g) whose weight ensured that no leakage of corrosive solution would occur around the base of the container.

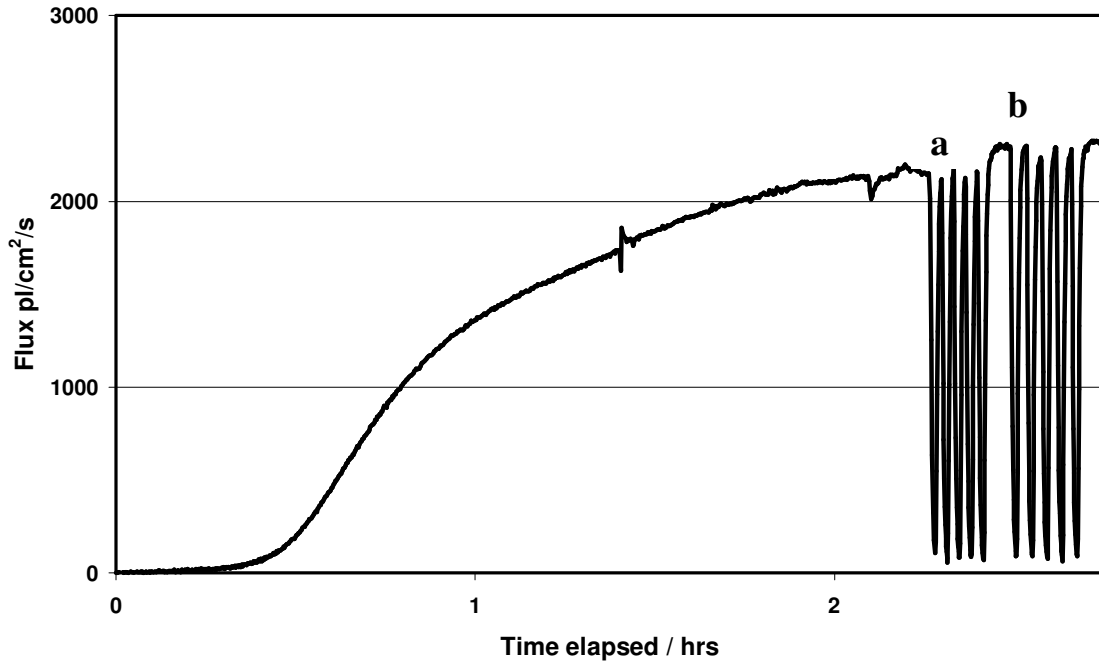
**Figure 2.** Hydrogen efflux onset at exit face of 3 mm Plate Steel following commencement of H<sub>2</sub>S saturation of NACE A solution at opposing entry face. Effect of probe detachment, 60 s, and re-attachment for **a**, 60 s seconds and **b** 90 s.

Once an invariant flux had been established the hydrogen collector probe was detached for 60 s and re-attached for 60 and 90 s as shown in Figure 2, points **a** and **b**, respectively. This exercise yielded a standard deviation in flux measurement delivered after 90 s probe attachment of 1% of the mean flux value obtained. The flux profile in subsequent days decayed approximately exponentially.

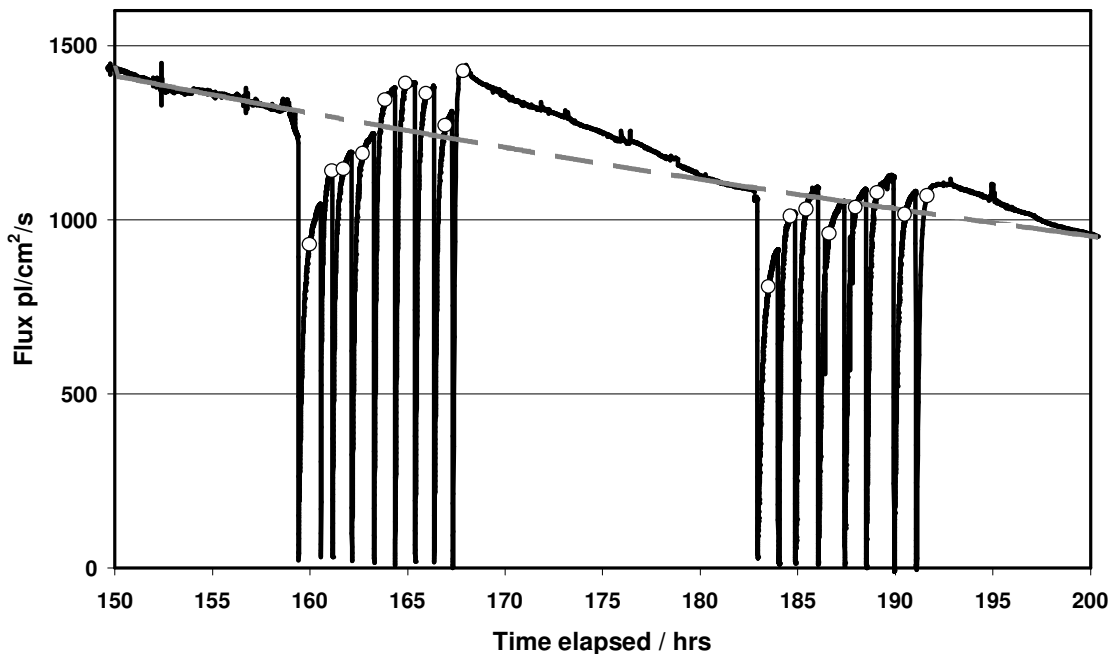
**Figure 3.** Effect of probe detachment, 80 s manual abrasion of steel exit surface with P120 SiC paper, followed by probe re-attachment on prevailing efflux transient obtained about a week after commencement of the experiment shown in **Figure 1**. Flux readings 2000 s subsequent to probe re-attachment are shown by open circles. The anticipated exponential decay profile for efflux without pre-treatment is shown as a broken line.

Over the period shown in Figure 3, the prevailing decay constant was 127 hr (*ie* decay by a factor of  $e \approx 2.7$  every 127 hr). During the time shown, two bouts of 85 s episodes of vigorous manual grinding of the efflux surface with P120 paper lead to a departure from this decay profile, anticipated in the absence of any such treatment, and shown as the smooth line in Figure 3. Note that during each bout of grinding, the criterion for a repeat grinding of the surface was that the flux had reached an approached a value stable to within 1.5 pL/cm<sup>2</sup>/s per minute.

For each bout of grinding, the most severe hydrogen ‘deficits’ as defined above, occurred subsequent to initial grinding episodes, as indicated by the 2000 s responses illustrated by open circles in Figure 3. This is again consistent with phenomenon *A* being the dominant cause of hydrogen deficit, as initial grinding would entail removal of a more air formed oxide, with consequently more disruption of the steel morphology. If phenomenon *B* was significant, initial hydrogen ‘deficits’ could only be expected to be *less* severe, due to incomplete oxide removal.

After each bout of grinding, a flux exceeding the decay profile for no surface treatment (broken line, Figure 3) was initially obtained. However, the actual profile then decayed until the anticipated profile was recovered. This is consistent with the formation of an oxide which substantially forms on a timescale of hours, the rate of formation decreasing with thickness. The flux from the air stabilized oxide film was some 90-95% of the maximum efflux obtained subsequent to mechanical oxide removal.

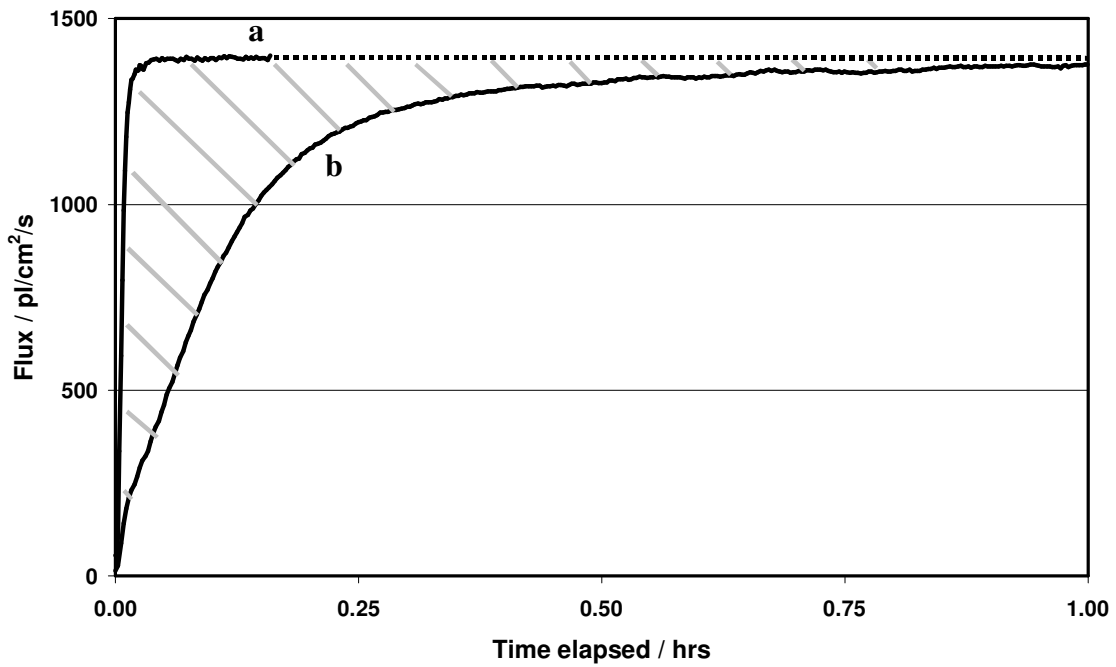
**Figure 4.** Detail illustrating 'hydrogen deficit', the area encompassed between this profile and a flux profile obtained in the absence of grinding. **a**, from **Figure 2** (2.6 hr); **b**, from **Figure 3** (164 hr)

After each episode of grinding, efflux *slowly* recovered to a new asymptotic value. **Figure 4** shows the flux response to one such episode, in contrast with the probe response to probe detachment and re-attachment. The hashed area curve corresponds to a volume  $V$  of hydrogen per unit area of steel ( $\mu\text{L}/\text{cm}^2$ ) which was not effluxed due to the preceding abrasion. Over all 15 grinding episodes  $V$  averaged  $3.86\mu\text{L}/\text{cm}^2$ , or approximately  $1.9 \times 10^{18}$  H atoms per  $\text{cm}^2$ . This should be contrasted with  $1.2 \times 10^{15}$  crystallographic sites for potential H chemisorption on alpha-iron. Allowing for a surface roughness factor of 2, the hydrogen 'deficit'  $V$  is some 75 times what would be expected from a simple requirement for pre-saturation of all available surface sites prior to the formation of hydrogen association at, and consequent desorption from steel, necessary for probe detection. Two effects may have contributed to the 'deficit'  $V$ :

A: Grinding will introduce a new, steel surface morphology, replete with empty hydrogen traps at the steel surface, requiring population by hydrogen prior to hydrogen efflux.

*B*: Freshly revealed steel may assist hydrogen oxidation by air, for example according to  $\text{Fe-H} + \text{O}_2 \rightarrow \text{Fe-O-O-H} \rightarrow$  iron (hydr-) oxides, decreasing hydrogen available for recombination and efflux until an oxide formed on the steel.

If *A* were pre-dominant, the deficit would be identifiable with a volume of hydrogen needed to fill traps introduced by grinding, achieved at a rate circumscribed by the sub-surface hydrogen flux; in contrast, effect *B* would be expected to affect efflux on a time dependent basis, defined by the rate of oxide formation, independent of flux. Since the average deficit for second bout of grinding was 96% of the first (3.78 vs 3.94  $\mu\text{l}/\text{cm}^2$ ), whereas the average end point flux of the second bout was 81% of the first, effect *A* was considered to pre-dominate.

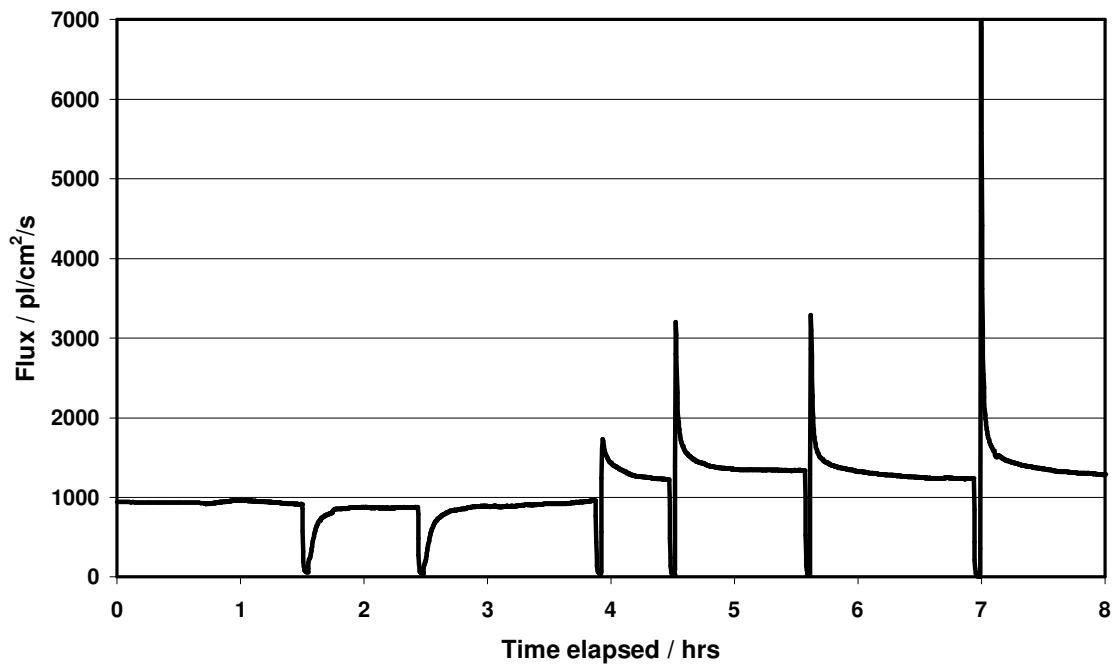
**Figure 5.** Effect of a series of 85 s treatments of an effluxing steel surface with 1 M sulphuric acid, applied manually with towelling soaked with the acid.

Figure 5 shows the effect of 80 s wetting with sulfuric acid on a surface pre-ground with P120 paper 16 hr previously. Initial treatments (1.5 and 2.5 hr) caused temporary reduction in response, though hydrogen efflux deficits were only some 5% those caused by grinding. Progressively transient hydrogen peaks were observed, and steady state flux increased markedly. This behaviour is consistent with initial consumption of acid in the dissolution of iron oxide:

So it did, increasingly progressively, as shown from the surfeit hydrogen generated in the latter profiles illustrated in Figure 5. despite drying of the surface with toweling. Even 0.1 microliter of the 1M diprotic sulfuric acid per  $\text{cm}^2$  steel, as an evaporative residue, corresponds to 2,200,000 pl hydrogen gas. Moreover, the accumulative formation of  $\text{FeSO}_4$  on the surface by reactions (4) and (5) would continuously promote hygroscopic conditions for moisture abstraction from the air, and subsequent corrosively generated hydrogen formation.

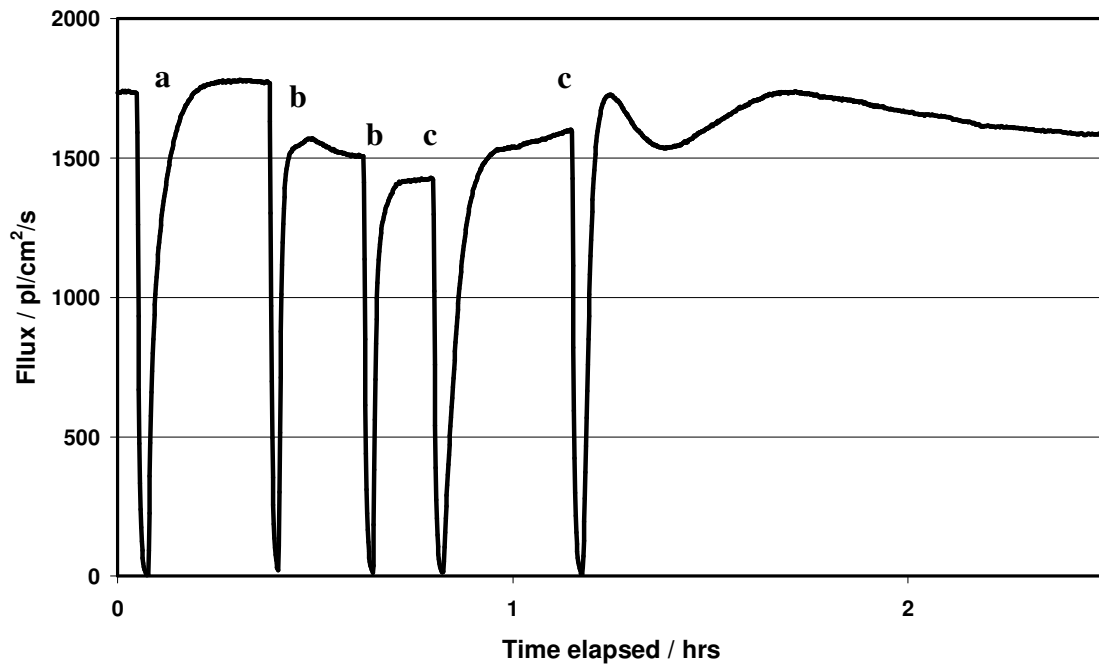
**Figure 6.** Effect of sequential treatments of an effluxing steel surface for 80 s. **a**, manual grinding with P120 paper; **b**, de-ionised water, and **c**, nitrogen purged NACE A solution.

The exit face of Plate Steel subject stable sour solution induced efflux was exposed to nitrogen purged ammonium hydroxide, NACE A solution and deionised water, within a few hours of P120 paper grinding. The effect of water and NACE A solution, a typical example of which is shown in Figure 6, was a temporary  $\pm 10\%$  disruption to the flux. Ammonia yielded similar profiles. On no occasion did exposure to these neutral or alkaline solutions lead to hydrogen flux deficits, as consistently occurred subsequent to manual abrasion.

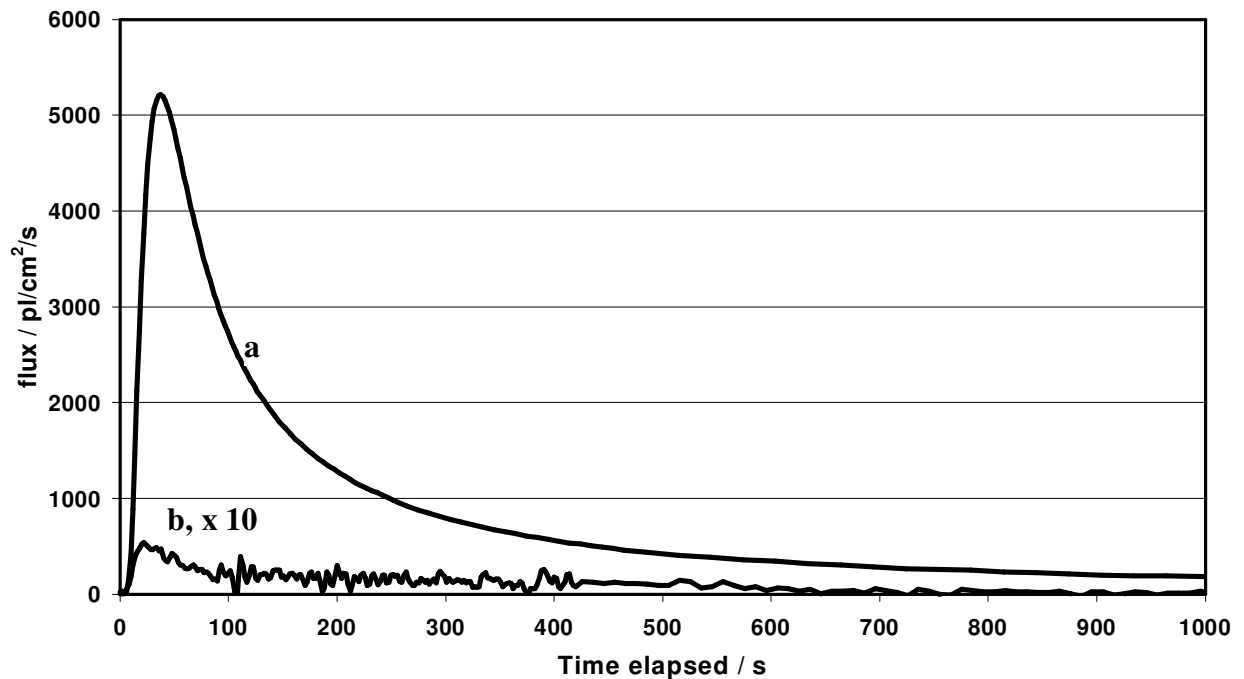
**Figure 7.** Efflux from a low carbon steel surface obtained within 10 s of 600 s exposure to **a**, H<sub>2</sub>S saturated NACE A solution, and **b**, nitrogen purged NACE A solution, flux scale x 10, for clarity.

The largest efflux recorded in consequence to 600 seconds exposure of a steel face to corrosive solutions, according to the four step procedure detailed above (see *Procedure*), was obtained from  $\text{H}_2\text{S}$  saturated NACE A solution. This is shown in Figure 7, together with the profile obtained from nitrogen purged NACE A solution. For an idealised steel, containing no hydrogen traps, the diffusion coefficient for the steel would be completely independent of hydrogen concentration. Consequently, one would expect flux values from any two solutions to be in strict proportion at all times elapsed since the steel was removed from a charging solution. This was not observed; weakly hydrogen charging solutions, such as obtained from the nitrogen purged NACE A solution, decayed from their peak flux values more rapidly than strongly hydrogen charging solutions. Both traps created during the pre-charge surface grinding, and pre-existing traps within the bulk metal explain this behaviour.

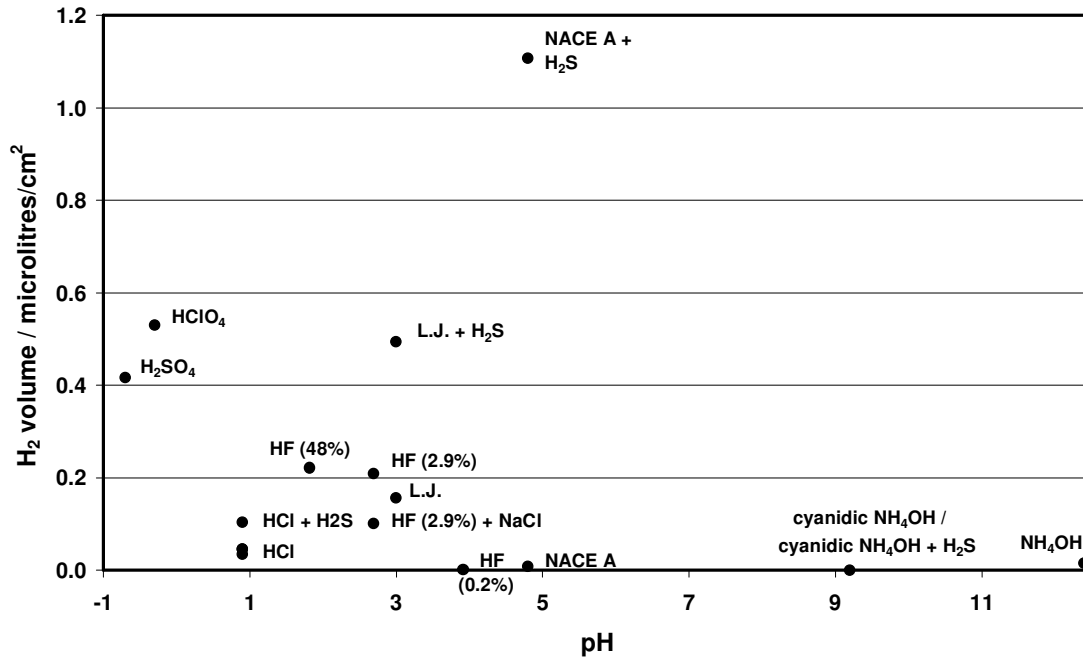
**Figure 8.** Total volume of hydrogen until the flux subsided to zero ( $\mu\text{l}/\text{cm}^2$ ) collected from a low carbon steel surface following 600 s exposure to various solutions. '+ H<sub>2</sub>S' indicates sour saturation prior to and during the solution exposure. Otherwise the solution was nitrogen purged throughout. For solution details see **Table 2**. L.J., lemon juice.

To compare the hydrogen occlusivity, that is, the hydrogen charging potential, of different solutions, the volume of effluxed hydrogen,  $V/cm^2$ , was calculated from the efflux profiles. Results for all solutions tested are shown in **Figure 8**.

Saturation of ammonia solution with  $H_2S$  was expected to generate  $(NH_4)_2S$ , ammonium sulfide, which is known to lead to hydrogen induced cracking, especially in the presence of cyanide and must therefore occlude hydrogen. However, no hydrogen efflux was observed by such solutions, with or without the addition of potassium cyanide. It is suspected that hydrogen charging is induced by an *excess* of hydrogen sulfide, and that in the solutions tested, the formation of ammonium sulfide was incomplete.

Strong perchloric and sulfuric acid promoted substantial hydrogen entry. In the absence of a hydrogen occluder, it appears that the formation of high concentrations of chemisorbed hydrogen by reaction (1) on the low carbon steel surface was sufficient to induce substantial hydrogen entry. Hydrogen charging was low in the higher pH solution, 1M HCl.

As a weak acid, hydrofluoric acid was identified as a hydrogen occluder, although the hydrogen volume effluxed from 0.2% hydrofluoric acid was negligible. Addition of 5% NaCl to 2.9% HF led to a lower hydrogen efflux. Since the NaCl would increase the conductivity of the solution, and hence enhance the rate of a corrosive reaction, it is suspected that the reaction of HF on steel does not proceed *via* an electrochemical mechanism.
